Manhole Inspection Summary

Manhole # S47A__021MH

Location Address: **Jefferson**

Cross Street: **Duncan**

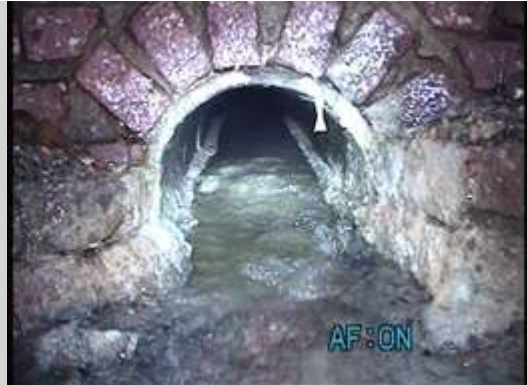
12 O'Clock Outflow

12 in. Circular Gravity Sewer
Pipe Out @ 12 O'Clock

Pipe Height: **12** (in.) Rod and Bar (Angled)
Pipe Material: **Clay** ☐ Pipe Lined
Invert Depth: **11.80** (ft.) Flow Characteristics: **Fast**
Deposits: ☒ None ☐ Mud ☐ Sludge ☐ Debris ☐ Grease
Silt Depth: (in.) Deposits Extent:
Infiltration: **None** Pipe Seal Cond: **Sound**

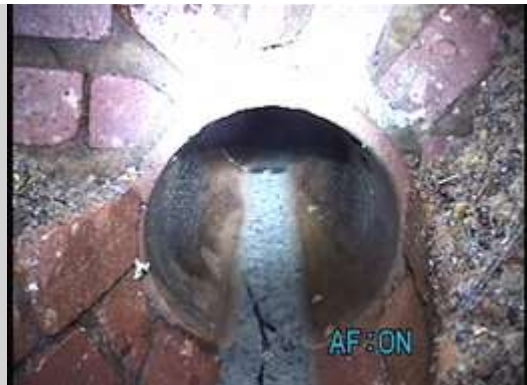
3 O'Clock Inflow

8 in. Circular Gravity Sewer
Pipe In @ 3 O'Clock

Pipe Height: **8.4** (in.) Rod and Bar (Angled)
Pipe Material: **Clay** ☐ Pipe Lined
Invert Depth: **11.25** (ft.) Flow Characteristics: **Fast**
Deposits: ☒ None ☐ Mud ☐ Sludge ☐ Debris ☐ Grease
Silt Depth: (in.) Deposits Extent:
Infiltration: **None** Pipe Seal Cond: **Sound**

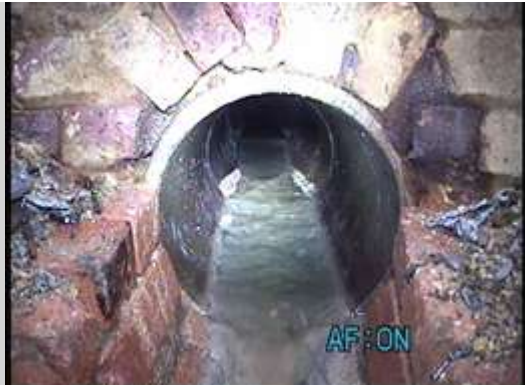
6 O'Clock Inflow

8 in. Circular Gravity Sewer

Pipe In @ 6 O'Clock

Pipe Height: **8.4** (in.) Rod and Bar (Angled)

Infiltration: **None** Pipe Seal Cond: **Sound**
